Manhole Inspection Summary

Manhole # S41E__059MH

Inspection ☐ Is Incomplete Rating: **5) Immediate Attention Required**

Location Address: **1300 e lombard st**

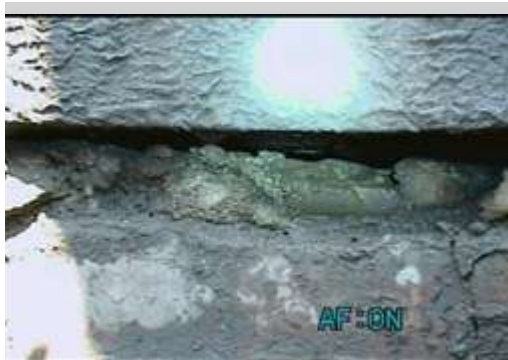
Defect 1

Condition: ☐ Sound ☐ Cracked ☐ Root Intrusion ☒ **Loose Brick** ☒ **Deteriorated**

chimney cond deteriorated, loose bricks

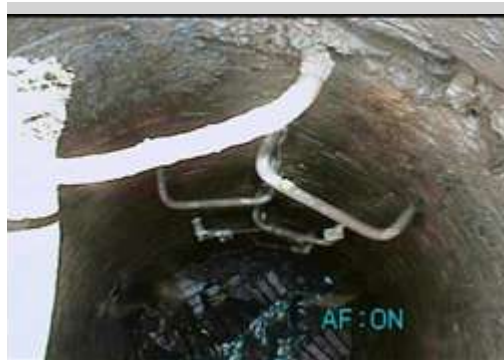
Defect 2

Count: **8** Missing: **0** ☒ **Corroded**

☒ **Evidence Of Surcharge** Depth: **5.3** (ft.) ☐ Active Surcharge Present

steps and evidence of surcharge

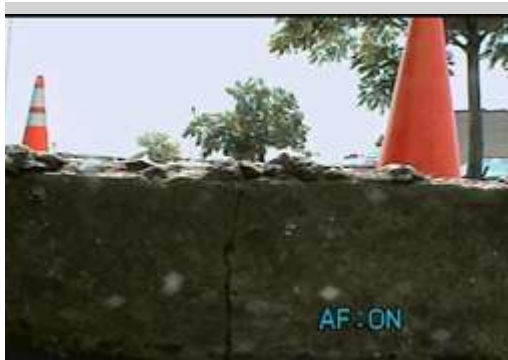
Defect 5

Condition: **Cracked**

cracked cover

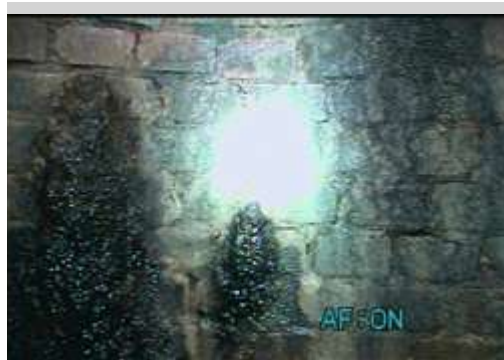
Defect 4

Infiltration: ☐ None ☐ Joint ☒ **Cracks** ☐ Mortar ☐ Roots ☒ **Wall**

barrel infiltration

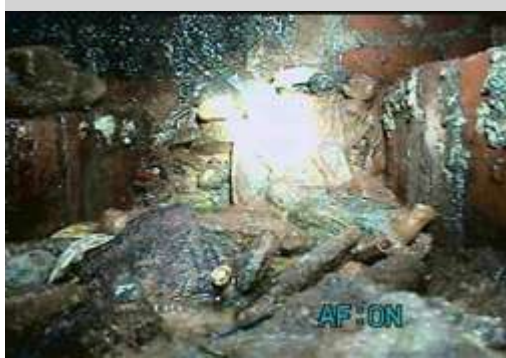
Defect 3

Condition: ☐ Sound ☐ Cracked ☐ Root Intrusion ☐ Deteriorated ☐ Leaks ☒ **Debris**

channel debris

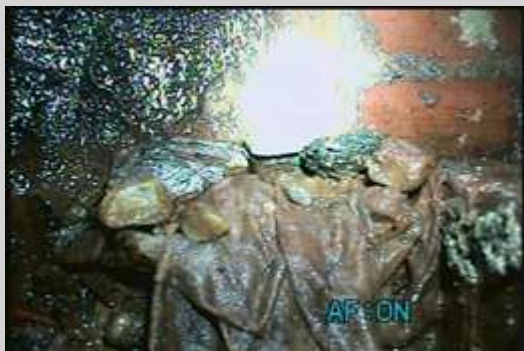
4 O'Clock Inflow

Deposits: ☐ None ☐ Mud ☐ Sludge ☒ **Debris** ☐ Grease

Silt Depth: 8 (in.) Deposits Extent: **Heavy**
